TECHNICAL BULLETIN

12000 Silicone Hose Advisory

May 25, 2021
ISSUE: 052521

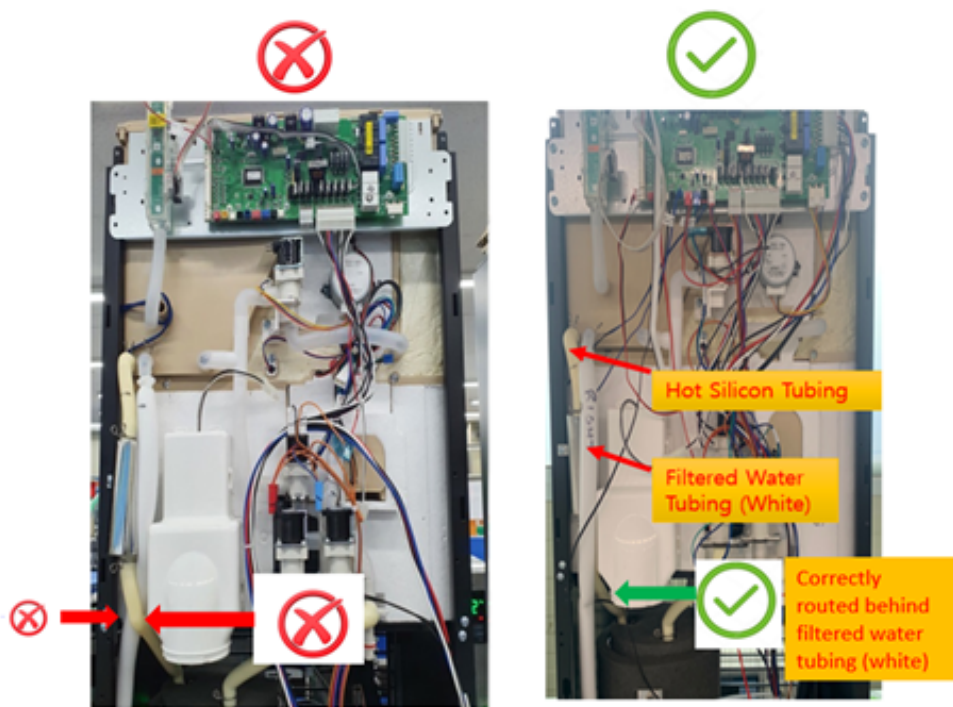
On certain units, the silicone tube connecting the water reservoir to the hot tank has been routed differently from its typical configuration. In some instances, this revised routing has increased the tension on the tubing, causing it to separate from the hot tank, resulting in a leak.

As illustrated in the picture at left below, the image with the **RED 'X'** shows the silicone tubing routed in front of the white tubing, which can create additional tension on the silicone tubing.

The image at right below with the **GREEN** check marks illustrates the silicone tubing properly routed behind the white tubing.

At time of system preparation, visually inspect that the tubing is routed correctly (please see the illustration above for reference) and that the clamp is properly secured (please see below image).

If applicable, please change the routing of the silicone tube to run behind the water line.

Verify that the silicone is properly seated to the hot tank.

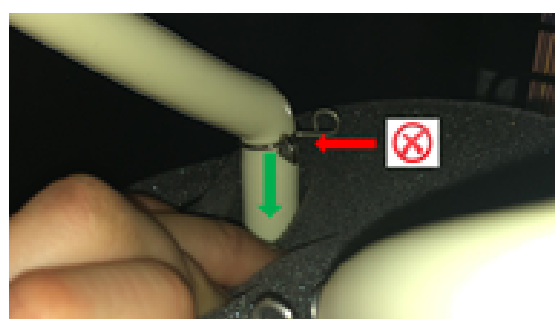
Hose clamp example. Ensure it is pressed all the way down.

Verify that the clamp is properly secured to the metal inlet tube coming from the hot tank.
