TECHNICAL BULLETIN

June 25, 2020
ISSUE: 062520

Issues Associated with Improper Foot Pedal Installation for the PWT 3i

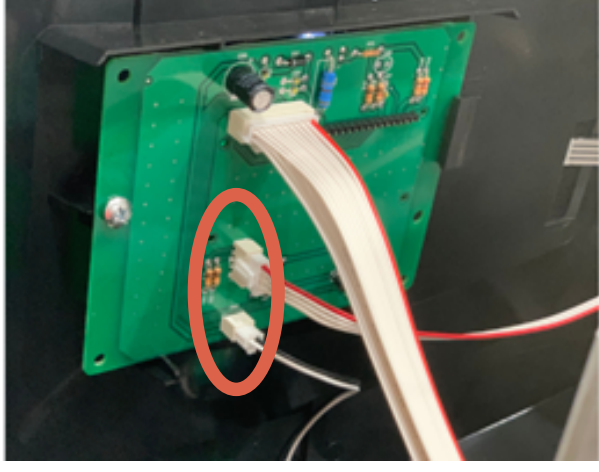
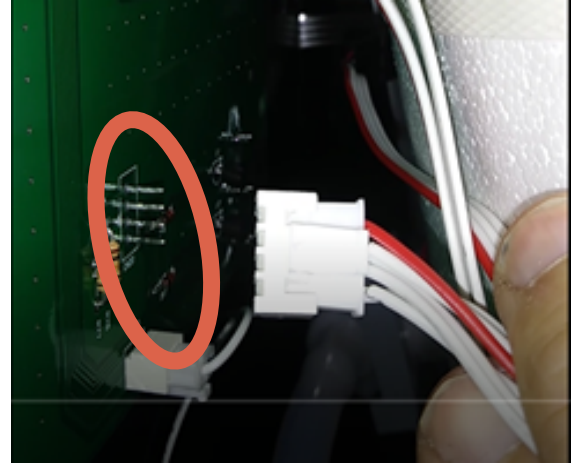
If this wire is pulled with too much force, the female ribbon connector will pull off the board. This may inadvertently occur when fishing the harness for the pedal and is therefore highly recommended to check all wire connections after installing the pedal

To resolve: Unplug your unit. Remove the front panel and correct the wire orientation according to the PWT 3i foot pedal installation guide.
