# TECHNICAL BULLETIN

September 25, 2020  
ISSUE: 092520

## Issues Associated with Dual Foot Pedal Installation for the PWT 3i

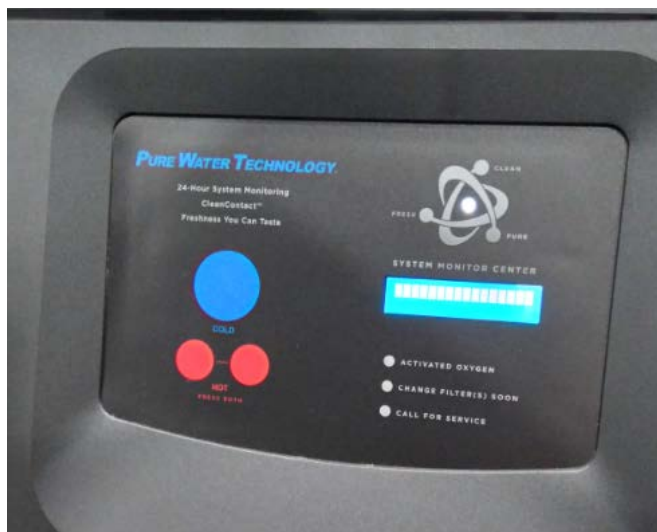
If installed incorrectly, the PWT 3i may display a blue or black LCD screen and the touchless-dispense dual pedal will not dispense hot or cold water. In some cases, an incorrectly installed dual pedal can cause the main board to permanently stop functioning.

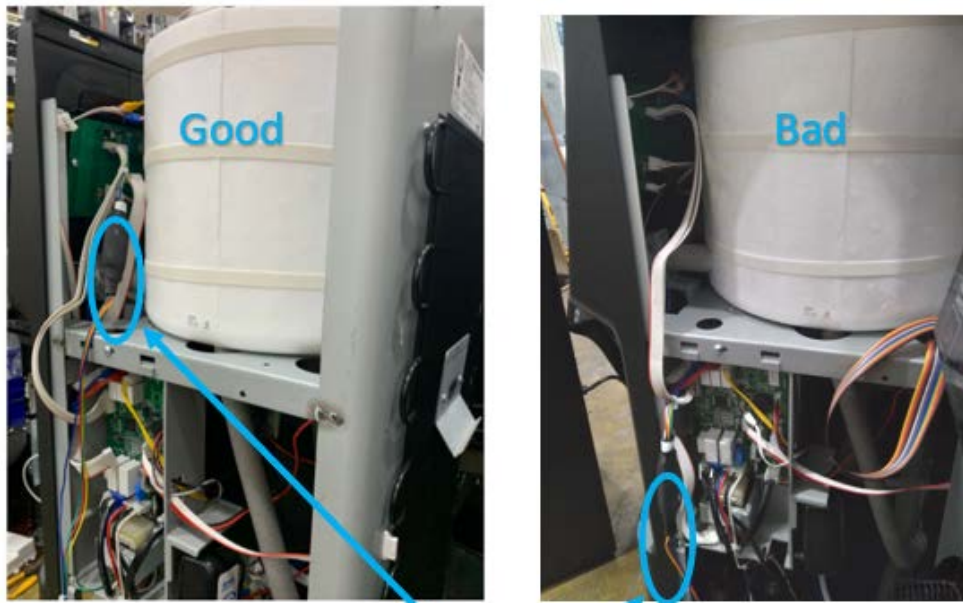
Foot pedal connections  
& heat shrink

**To resolve:** Double-check that the ribbon cable was installed correctly, according to the provided installation guide. Specifically, make sure that the end of the cable (the end with pedal connections and the black heat shrink) is connected to the **display board**, not the main board.

Turn the power off to the PWT 3i unit.

Re-install the ribbon cable correctly utilizing the provided installation guide.

Test the pedal.\*

\*If the cable was installed backwards while the unit was still plugged into the power source, the main board will have to be replaced before the pedal will operate.
